In large industrial cooling water systems (CWS), in particular once through cooling systems (OTC), biological growth on surfaces, a phenomenon usually known as “biofouling”, causes a number of issues. The very first phase, a layer of bacteria (biofilm) that forms in a few hours, already contributes to:

In the OTC of this large power plant, chlorine dioxide was dosed on a daily basis, as a shock treatment (Fig. 1). This strategy was fine tuned to achieve the best efficiency, reducing at the same time as much as possible the corrosion of the old heat exchangers - caused both by bacteria (microbially influenced corrosion, MIC) and by the oxidizing chemical.

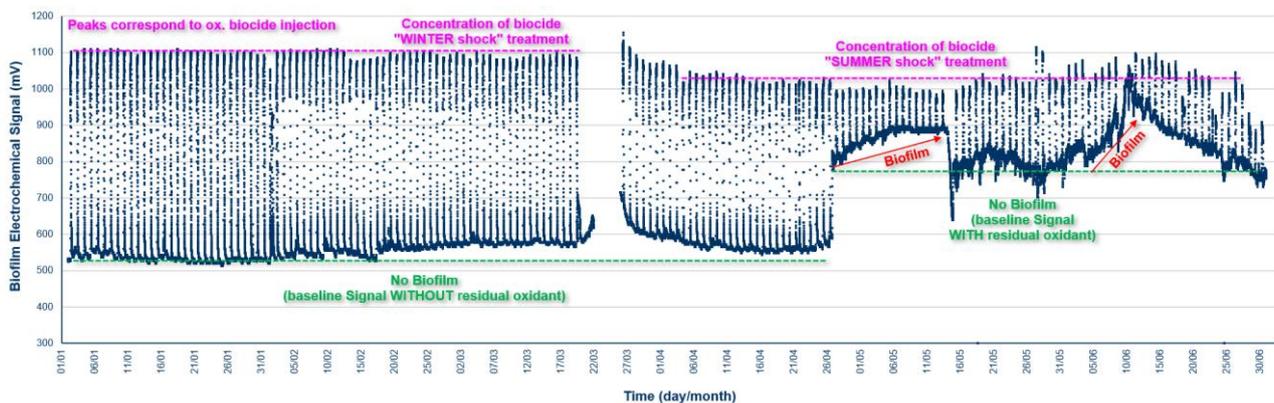
Figure 1: ALVIM Signal in the once-through cooling water system of this power plant; purple dotted lines mark the level reached by ALVIM Signal when chlorine dioxide was shock-dosed; green dotted lines mark baseline Signal with no biofilm; red arrows mark biofilm growth

- a sharp and large increase when oxidizing agents are dosed – the increase is proportional to the concentration of the chemical;
- an increase in the baseline when residual oxidant is present;
- a gradual and stable increase over time (hours-days) when biofilm grows;

looking at Fig. 1, it can be noted that, from early January to late April, the daily treatment was able to keep biofilm growth under control. Since April, the concentration of the shock dose was reduced – as it can be noted observing the decrease in the daily peaks of ALVIM Signal (purple dotted line, in the figure). Then, in addition to the shock treatment, a continuous injection of chlorine dioxide (at low concentration) was applied, as highlighted by the increase in the baseline Signal (green dotted line, in the figure). Nevertheless, this was not enough to completely prevent biofilm growth, in this warmer season – indeed, a couple biofilm growth events were detected in May and in June. However, the biocide treatment was effective enough to remove settled bacteria in a short time, as it can be noted by the following decrease in ALVIM Signal, back to the baseline.
