In water bottling plants, bacterial growth on surfaces (biofilm) can represent a serious threat to human health, since this microbiological layer is the ideal environment for the survival and growth of pathogenic bacteria. Moreover, biofilm can be up to 1000 times more resistant to sanitation treatments with respect to free-floating bacteria. Detection of biofilm and prevention of possible biological contaminations is, therefore, of primary importance.

In this water bottling plant, the sanitation treatment of pipelines and tanks was applied at predefined times. No verification procedure was carried out to check the effectiveness of this treatment, before the installation of ALVIM System.

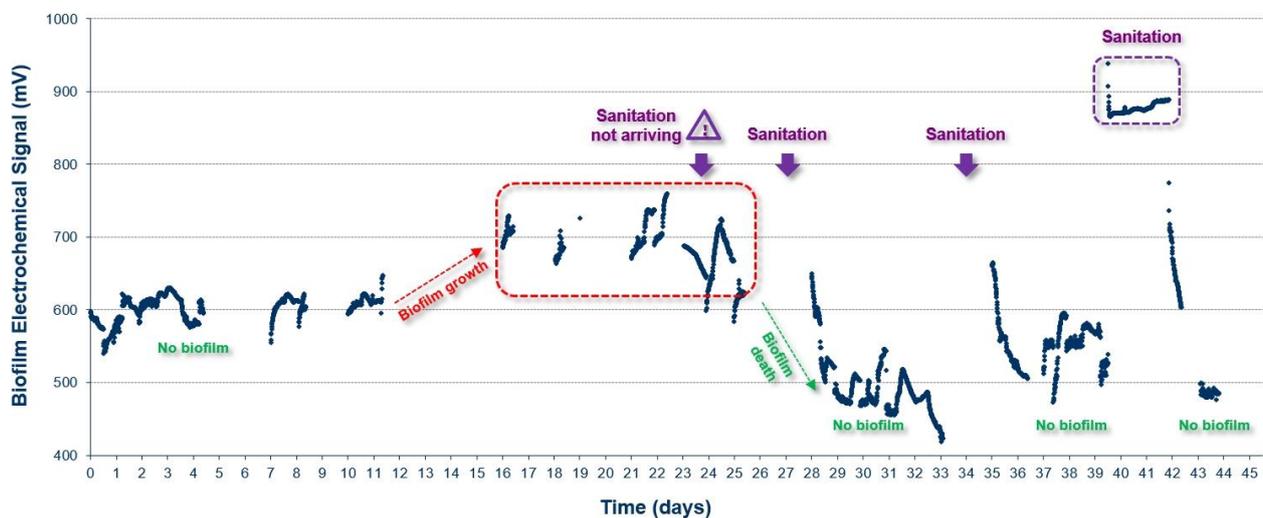
Taking into account that ALVIM probe indicates:

- the dosage of oxidizing agents through a sharp and large increase of the signal, and
- biofilm growth through a relatively slow increase in the Signal of 150 mV and more, with respect to the baseline value (in this case about 550-600 mV, marked in the figure as "No biofilm"),

after some weeks of use of the ALVIM Biofilm Sensor, the plant technical staff was able to detect that, in the pipe where the probe was installed, the cleaning treatment was not working appropriately. Starting from day 16 (see the graph), ALVIM signal indicated biofilm growth. Moreover, when sanitation was applied (see day 23) the sensor did not detect any oxidizing agent. The technical staff discovered that, due to a wrong configuration of a valve, the line where the Sensor was installed was never treated (see figure below).

Sanitation procedure was thus modified, to solve the problem. Following this change (see the graph, from day 26), ALVIM signal decreased below risk level and it never highlighted biofilm growth again. At the same time it can be observed how, following the solution of this problem, the application of sanitizer was detected by the sensor (see days 39-41).
